BIOS Release Notes

Intel® Core™ processors (12th/13th/14th Gen)

mITX and μ ATX Series (R2.*.0)

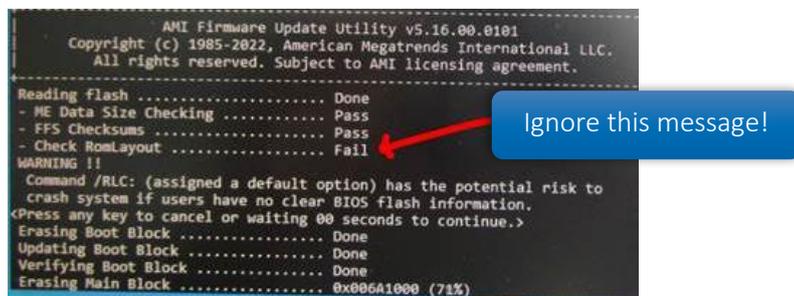
2.6 Message “Check ROMLayout ... Fail”

If you encounter a message during BIOS update batch run with “Check RomLayout Fail” please treat this message only as information. AfuUpdate report this message if there is a ROM layout change in BIOS NVRAM, but the BIOS code can handle this change. **Do not interrupt or interact in this state with the console or shell.**
