# BIOS Release Notes

Intel® Core™ processors (12th/13th/14th Gen)

## mITX and µATX Series (R2.\*.0)

- K3831-H1 Thin-Mini ITX
- K3832-Q1 Mini-ITX (ATX12VO / 12VDC)
- K3833-Q1 Mini-ITX (ATX Multirail)
- K3836-Q1/R1 Mini-ITX (ATX Multirail / 12VDC)
- K3841-Q1 µATX
- K3842-Q1, K3842-Q2 µATX
- K3843-B1, K3843-B2 µATX

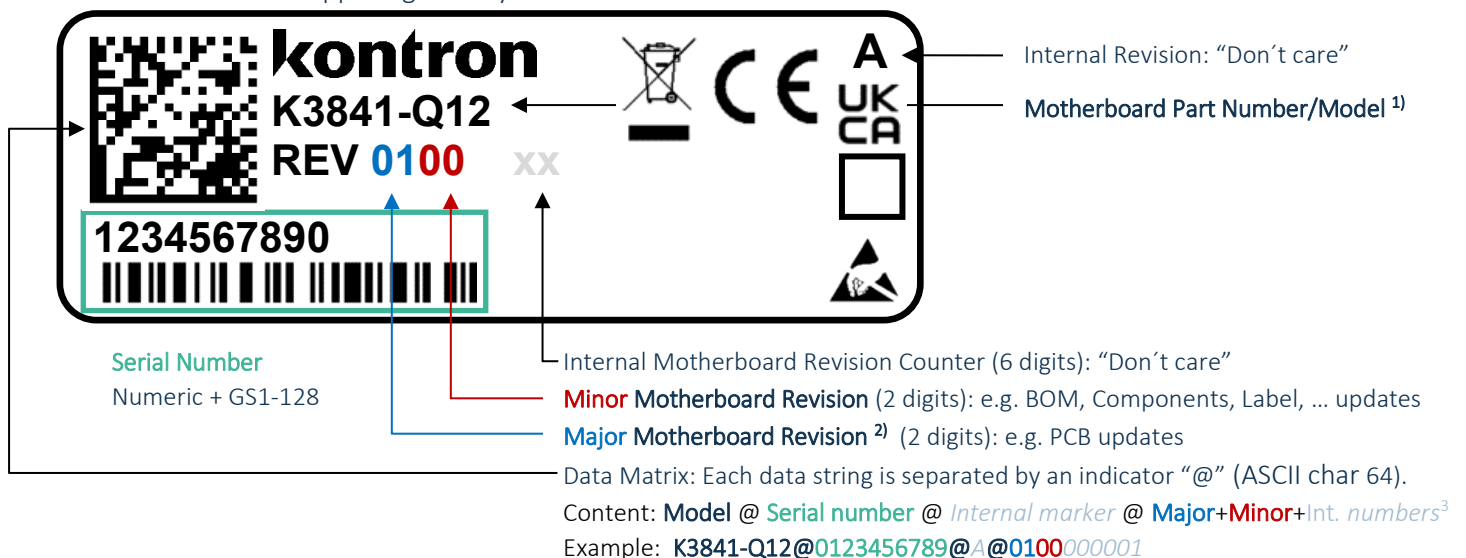
### New motherboard type label (introduced with K3836-Q/R in 11/2024).

This new label will be applied gradually to all K38xx motherboards in 2025.

1) Motherboard part number example:

- K3841-Q12:
  - **K38**41-Q12: Kontron boards family (technology based family)
  - **K3841**-Q12: Formfactor and board variant
  - **K3841-Q12**: Number for derivate of board variant
  - **K3841-Q12**: PCB version

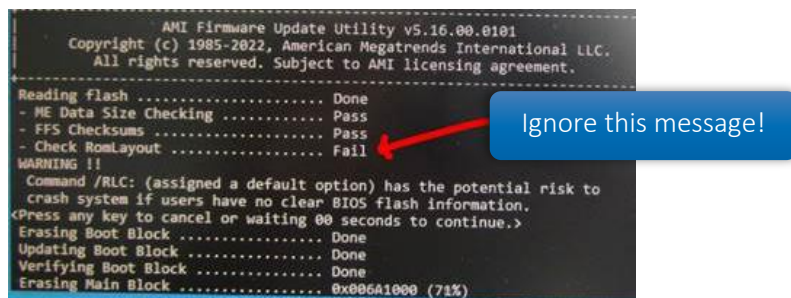
## 2.6 Message “Check ROMLayout ... Fail”

If you encounter a message during BIOS update batch run with “Check RomLayout .... Fail” please treat this message only as information. AfuUpdate report this message if there is a ROM layout change in BIOS NVRAM, but the BIOS code can handle this change. **Do not interrupt or interact in this state with the console or shell.**

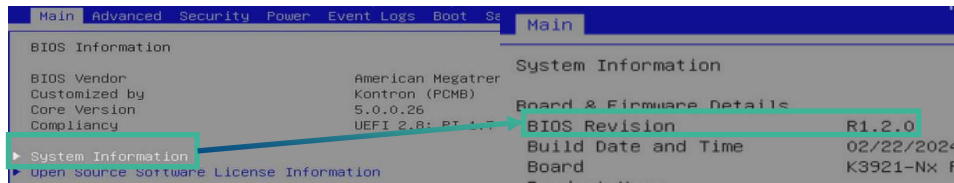
### 3.2 Kontron BIOS version

The installed Kontron BIOS version on a target machine can be found within [Main > System Information] in setup UI.
