BIOS Release Notes

Intel® RaptorLake-S (R2.*.0)

➤ K3851-R ATX

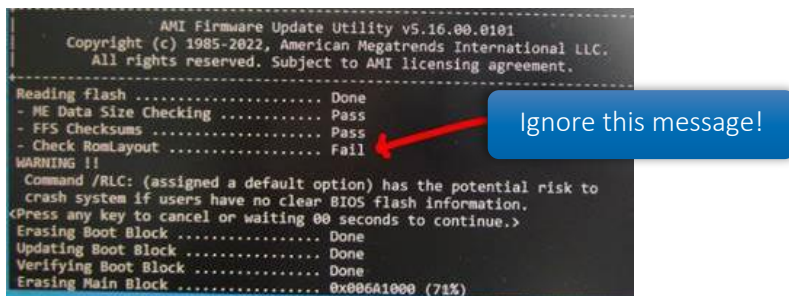
2.6 Message "Check ROMLayout ... Fail"

If you encounter a message during BIOS update batch run with "Check RomLayout Fail" please treat this message only as information. AfuUpdate report this message if there is a ROM layout change in BIOS NVRAM, but the BIOS code can handle this change. **Do not interrupt or interact in this state with the console or shell.**
